Manhole Inspection Summary

Manhole # S33KK1020MH

Insp Date: **4/28/07 9:12 AM**

Location Address: **4221 GREENWAY**

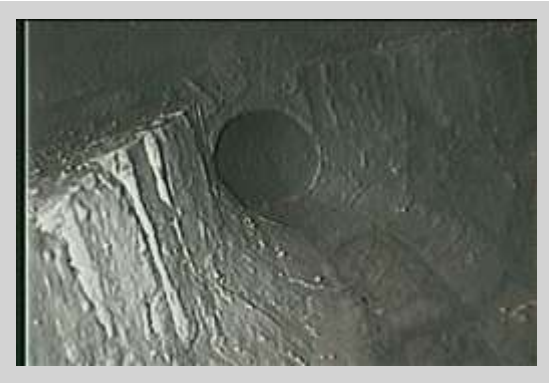
6 in. Circular Gravity Sewer Pipe Out @ 12 O'Clock

Rod and Bar (Angled)

Infiltration: **None** Pipe Seal Cond: **Unknown**
